**Repairing fractured porcelain-fused-to-metal  
bridge pontics**

FRED C. QUARNSTROM and TAR C. AW  
*J Am Dent Assoc* 2003;134;1097-1100

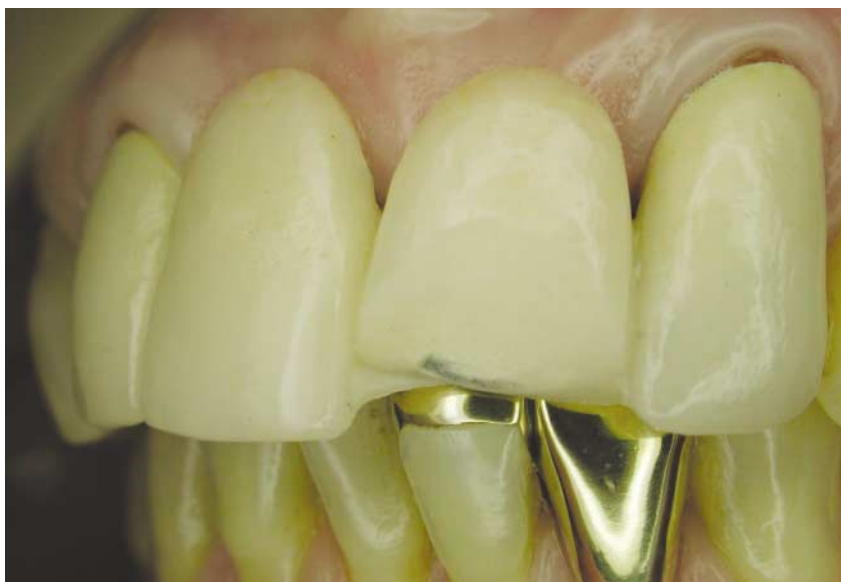
**Figure 1. The fracture as viewed from the labial aspect.**

When a pontic fractures, our solution is technically simpler than others and can more easily achieve a very satisfactory result. Figure 1 shows a typical anterior three-unit bridge (teeth nos. 8-10) that was fractured in an altercation (in which the injured patient allegedly was an innocent bystander). The patient came to our office as a new patient with limited funds, requesting a repair. She reported that the bridge was more than 15 years old and that she had been happy with its appearance and function until it was fractured and the entire incisal edge was destroyed.

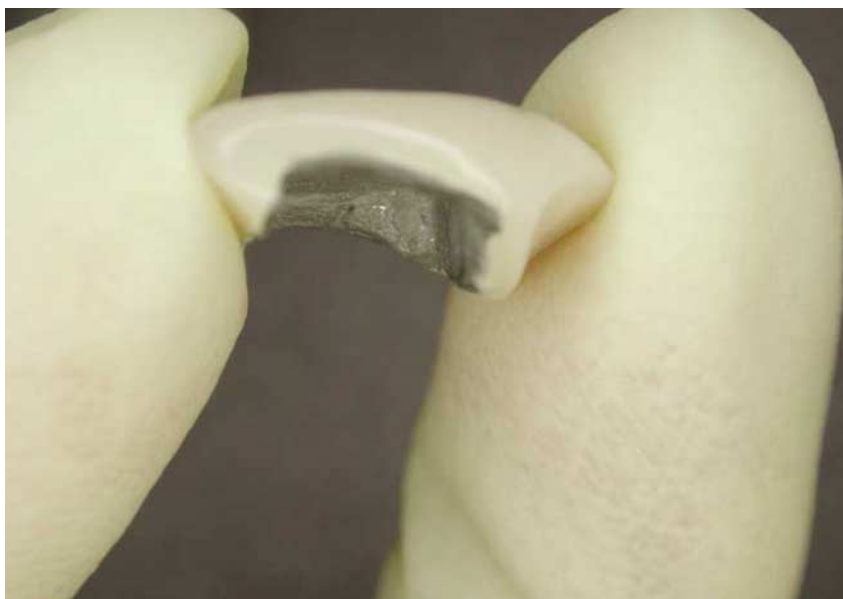
**Figure 3. The overlay crown pontic.**

restoration short enough to be out of occlusion. The laboratory fabricated an overlay crown that had a metal coping with extensions into the incisal and gingival porcelain and proximal boxes to slot into the connectors, like a jigsaw puzzle (Figure 3). The surfaces that would contact cement were left unfinished and were sandblasted for additional micromechanical retention. When he received the overlay pontic from the laboratory, the clinician took it to the mouth, inserted it and adjusted it for fit and occlusion. He prepared both metal surfaces for cementation with primers and bonding agents according to adhesive cementation protocols, and then he cemented the overlay crown pontic with the corresponding resin cement.
